Hydro-generator condition-based monitoring system modernisation for maintenance optimisation

Aaron Doyle, P.Eng. – IRIS Power (Qualitrol)

Machines 2025

Presented by Rob Higgs, CPEng RPEQ – machinemonitor®

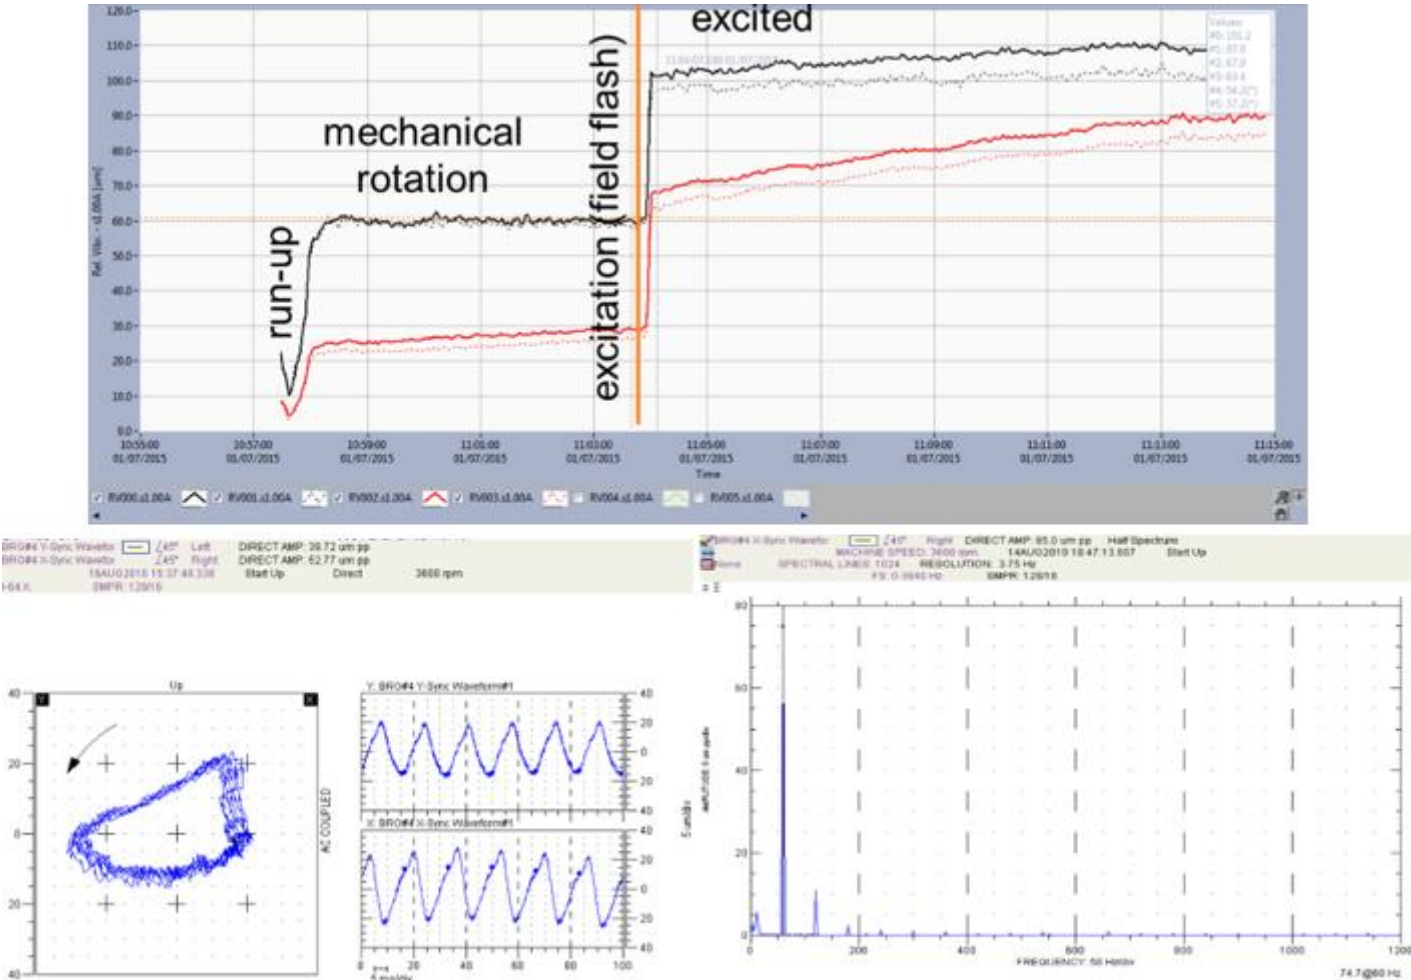
Vibration – Overview

Widely adopted, good for many mechanical failure modes:

- *unbalance, misalignment, looseness, bearing degradation*

Data plots include trends, waveform/orbit, spectra, polar/bode, and shaft centerline

Typical measurements include:

- Shaft Relative Vibration– Proximity Probes
- Bearing Absolute Vibration – Accelerometers

Supplementary measurements:

- Frame/Core Vibration, Endwinding Vibration (Fiberoptic Accelerometers), Turbine specific, and Auxiliaries

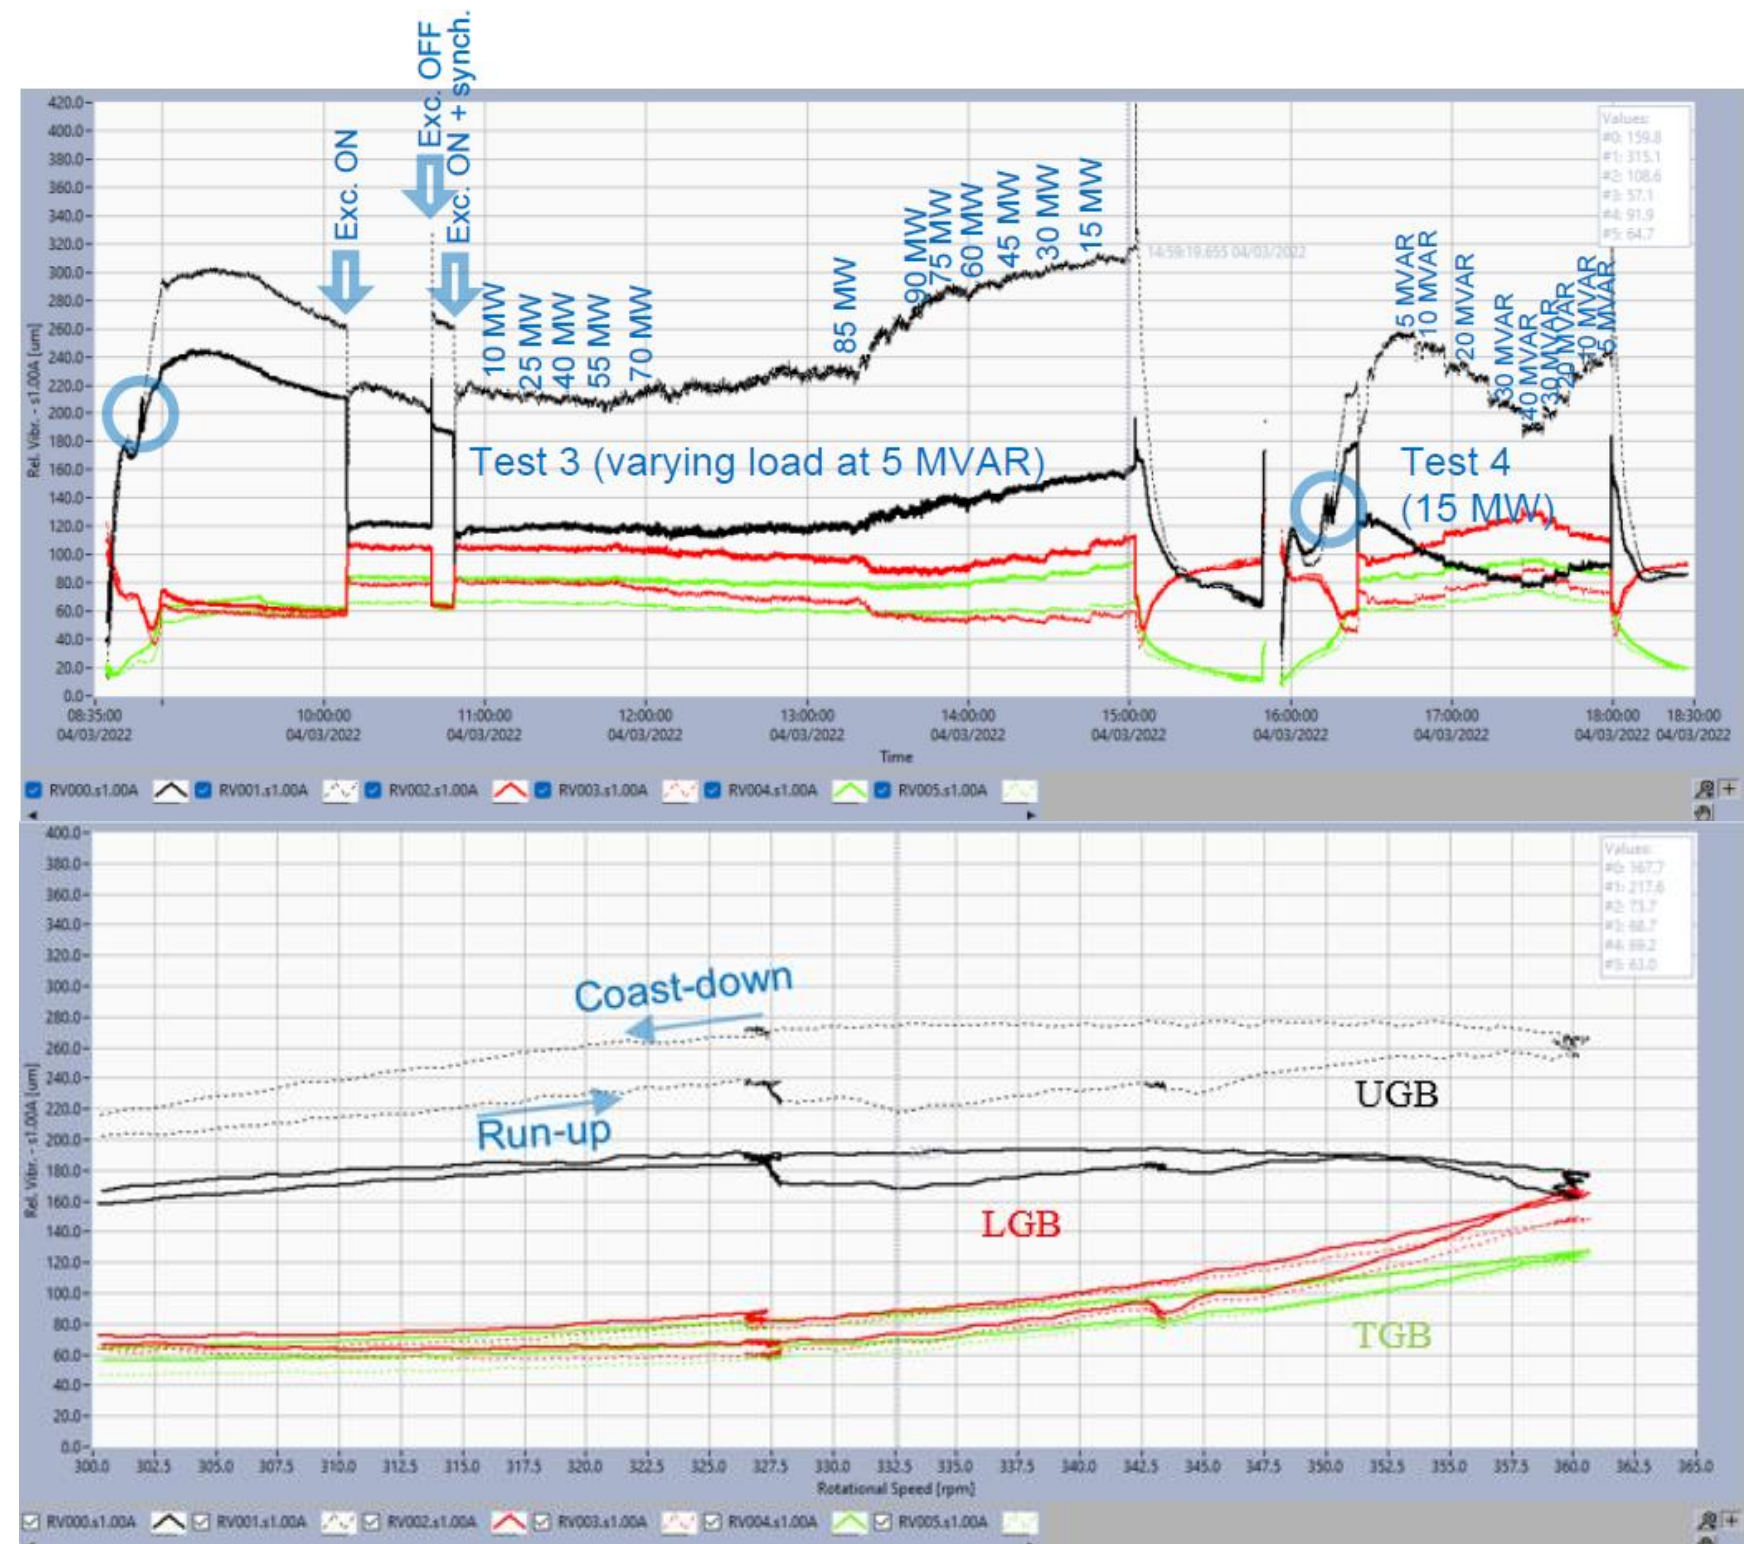
Vibration – Case Study

120MW, 22 pole unit in North America

Upper Guide Bearing (UGB) vibration **(black lines)**

- On startup at 240-255 RPM UGB vibration would decrease –mechanical unbalance changing
- Non-repeatable under load – increasing above ~85MW, continuing after load reduced
- Following overspeed test at 110% of nominal speed UGB vibration changed

Temporarily reduced vibration by balancing, but problem re-occurring – *root cause suspected to be rim to spider fit*

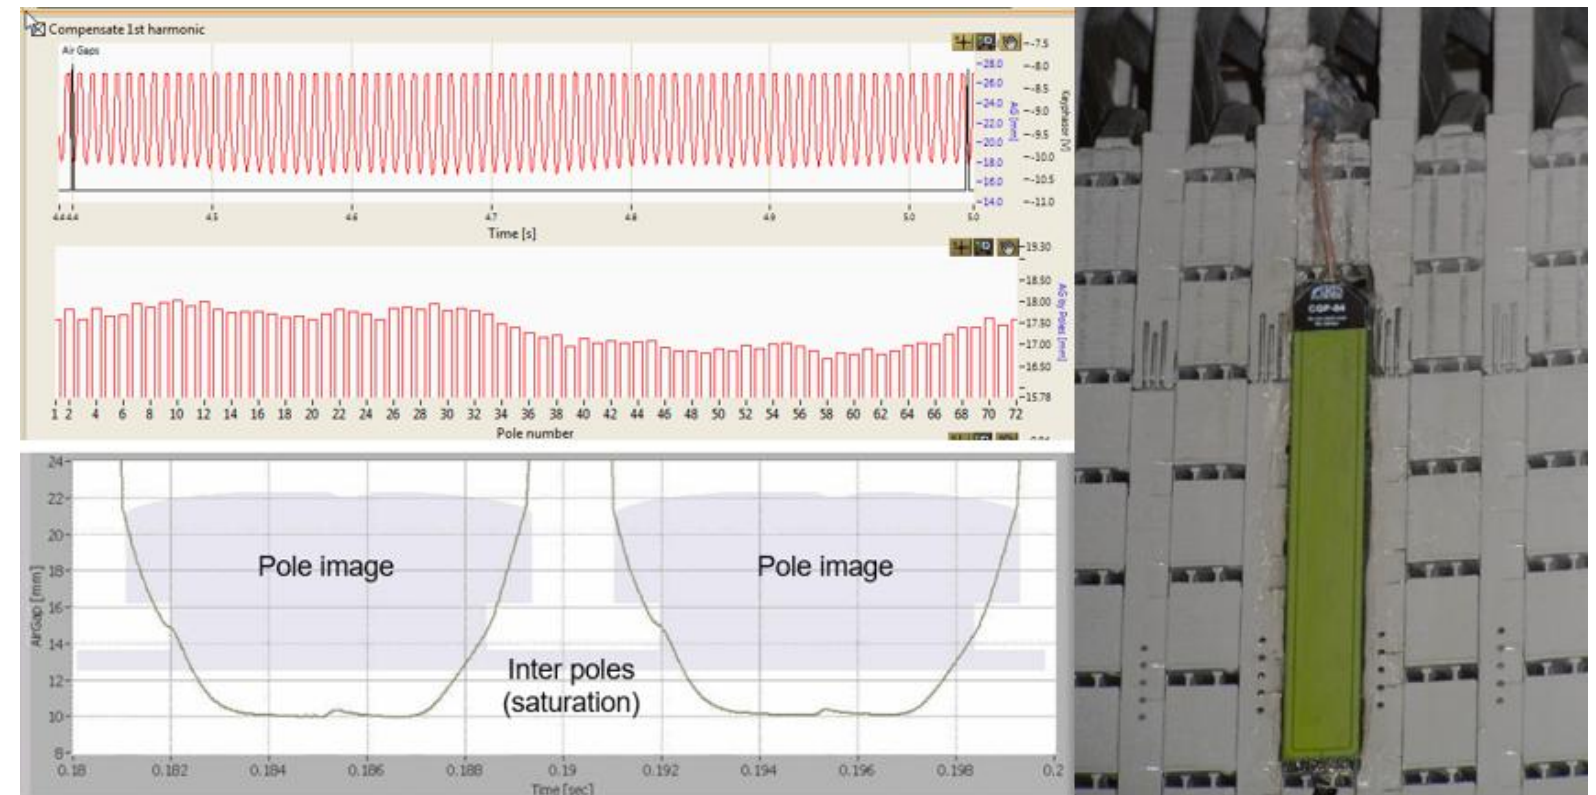
Airgap – Overview

Specific to salient pole rotors – large low speed hydro's

- Rotor rim – floating vs shrink fit
- Identifies rim looseness, spider deformation, foundation and frame weakness

Application:- 4+ probes mounted on stator tooth – directly measure air gap

Measured:- Rotor/stator concentricity/circularity, min/max/average air gap (by pole), dynamic eccentricity (precession) of rotor in air gap

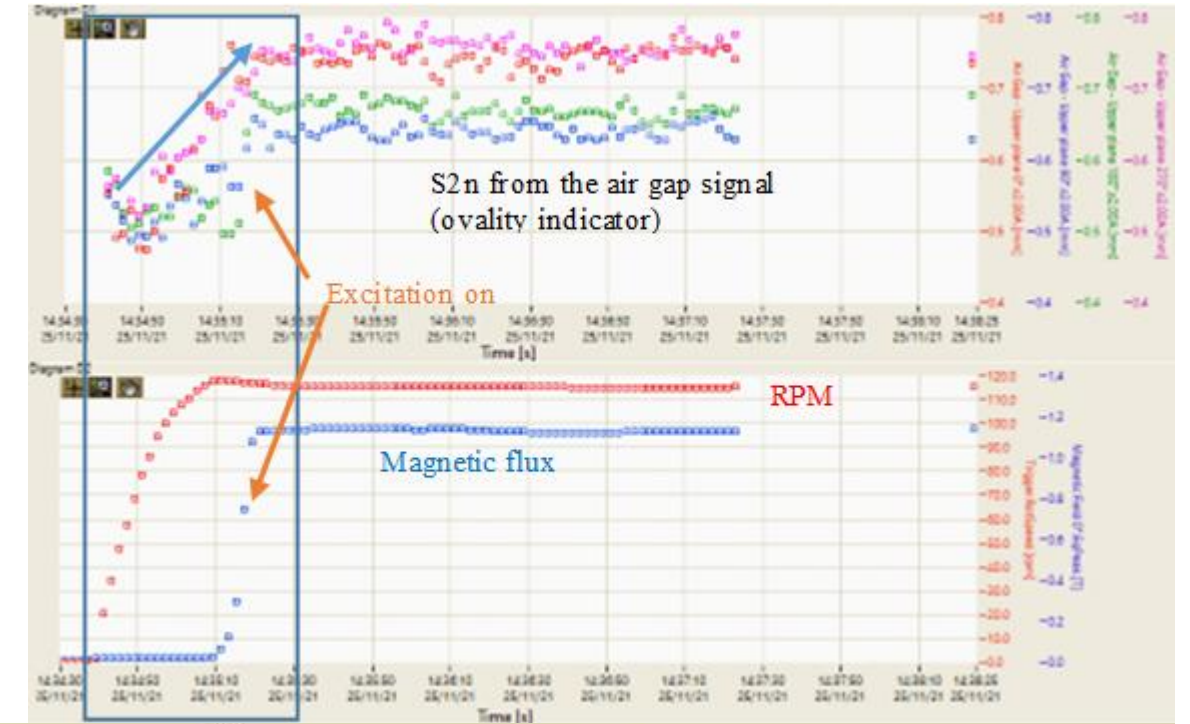
Airgap – Case Study

125 MW, 52 pole unit in Europe

- During startup, twice turning speed frequency component observed in the airgap vibration data – rim ovality
- At nominal speed, with field excitation applied, elliptical shaped and poor circularity confirmed
- Root Cause – Relaxation of the rim's shrink fit due to high centrifugal forces & thermal cycling over time

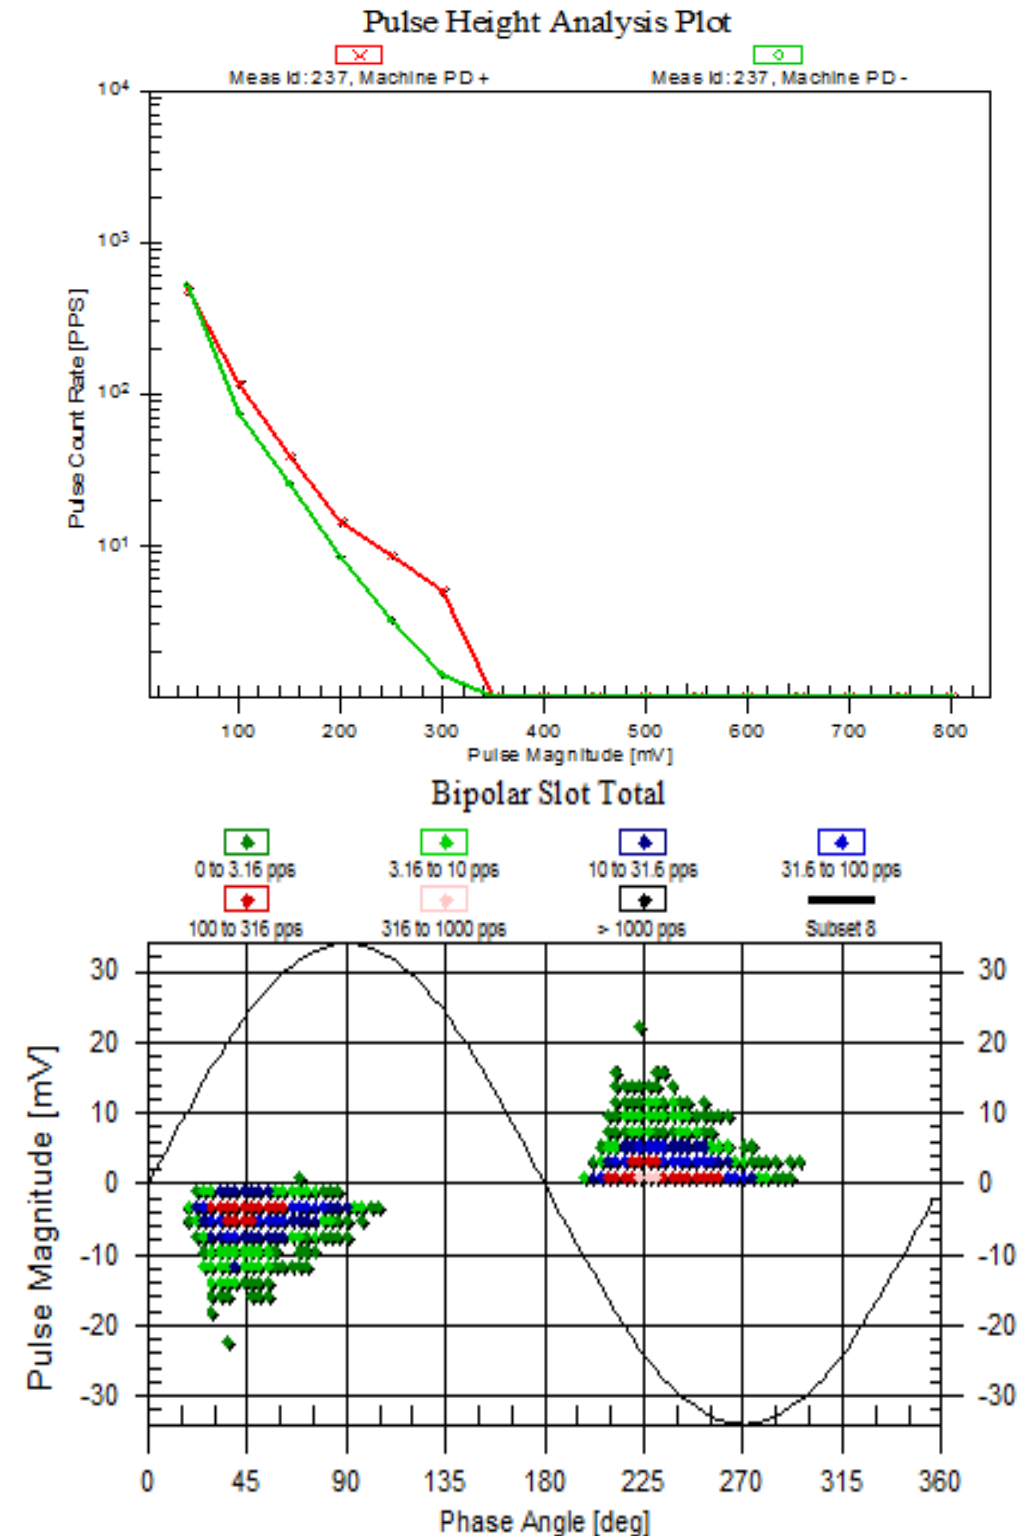
Partial Discharge – Overview

Specialised monitoring for stator winding insulation

- Long history and widely adopted in both hydro and turbo generators
- Used to identify insulation abrasion due to loose coils/bars in the slot, insulation delamination due to thermal deterioration or load cycling, electrical tracking caused by contamination, poor epoxy impregnation, and insufficient coil/bar clearances in the endwindings

Sensors measure very small current/voltage pulses – high frequency current transformer at the neutral point, high voltage capacitors at the phase terminals, or radio frequency antennae

- 2D analysis – number of PD pulses versus PD magnitude
- 3D analysis – phase resolved PD (PRPD) shows number and magnitude of PD pulses versus ac phase angle

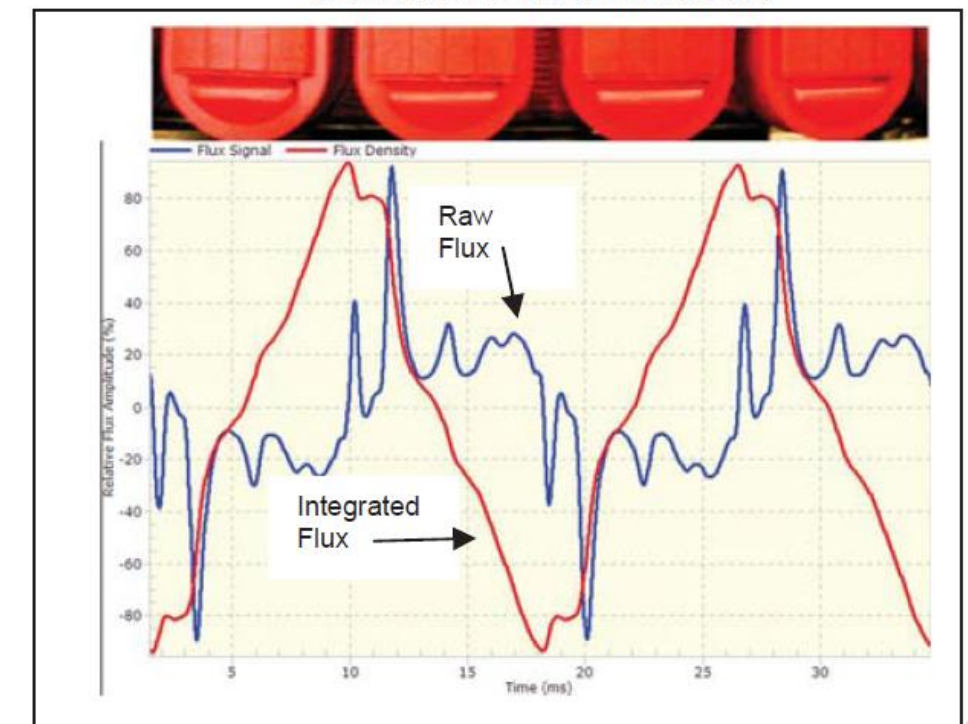
← direction of rotor movement

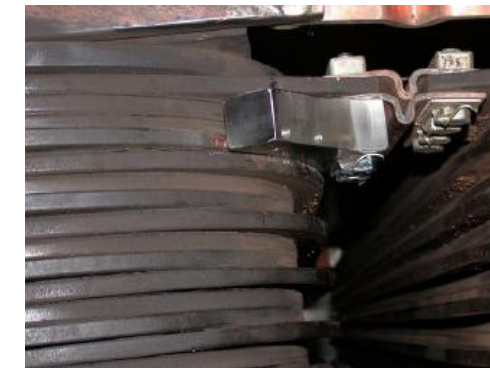
3 shorted turns

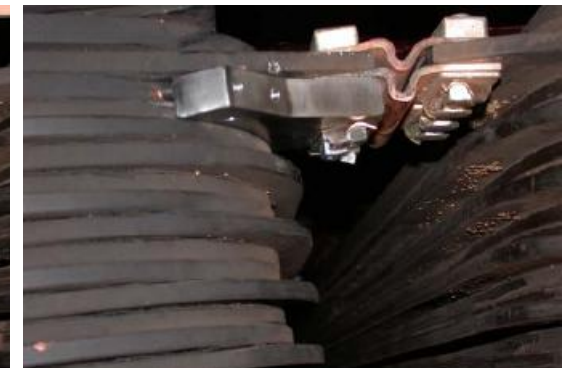
1 shorted turn
