# MAKING THE RIGHT CALL: REPAIR, REPLACE, OR EXTEND ASSET LIFE?

Shantanu Bendre (Yarra Valley Water)

## CASE STUDY: SWITCHBOARDS

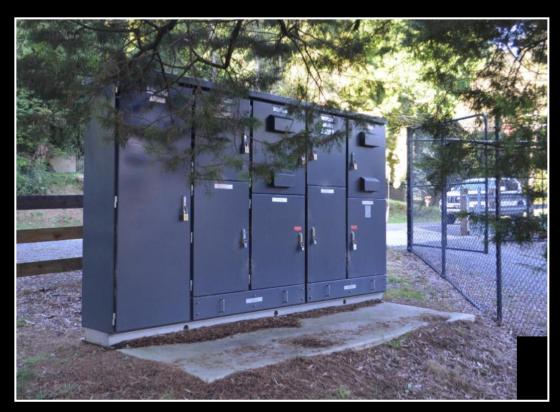
TYPICAL SEWAGE PUMP STATION MAIN SWITCHBOARD

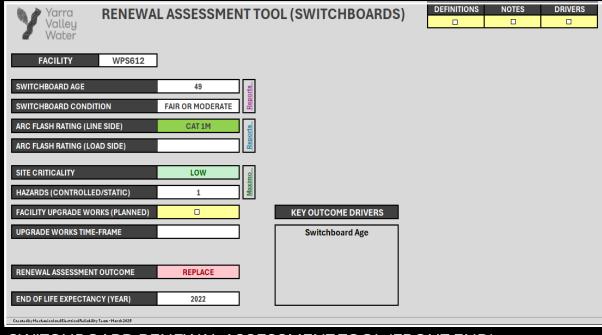
#### SWITCHBOARD RENEWAL ASSESSMENT TOOL (FRONT END)

- This triggered a review exercise that led to the creation of the Renewal Assessment Tool.
- This tool weighted and rated the different variables that contributed to the decision of replacing a switchboard —
  - Age
  - Condition
  - Hazards
  - Arc flash rating
  - Site criticality
- One major difference in the input of the tool was that the usable age of the switchboard was 49 years, which was based on the empirical data of the existing YVW switchboards.
- The use of the tool changed the CAPEX profiling of the switchboards. As a result, YVW saw fewer switchboards being replaced in a financial year.

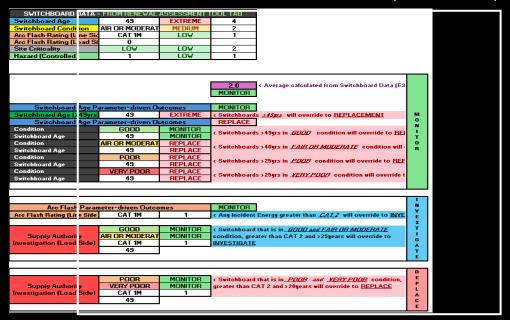
SWITCHBOARD RENEWAL ASSESSMENT TOOL (BACK END)
